Python target grip reference guide

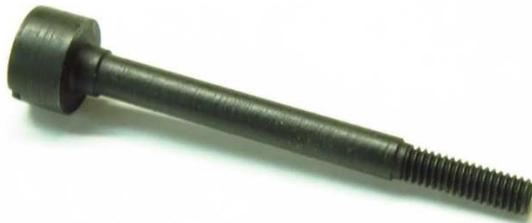
Original Python grip screw. Note the reduced diameter thread and the large head.

One good way of identifying original Colt grips is to study the hardware. Colt used an easily recognizable screw in all three generations of the target grips, and one characteristic feature is the tall screw head. Also note the rather small #2-64 thread, which makes the shank noticeably larger in diameter than the threaded section. The screws were always installed from the left side, with no escutcheon in the hole.

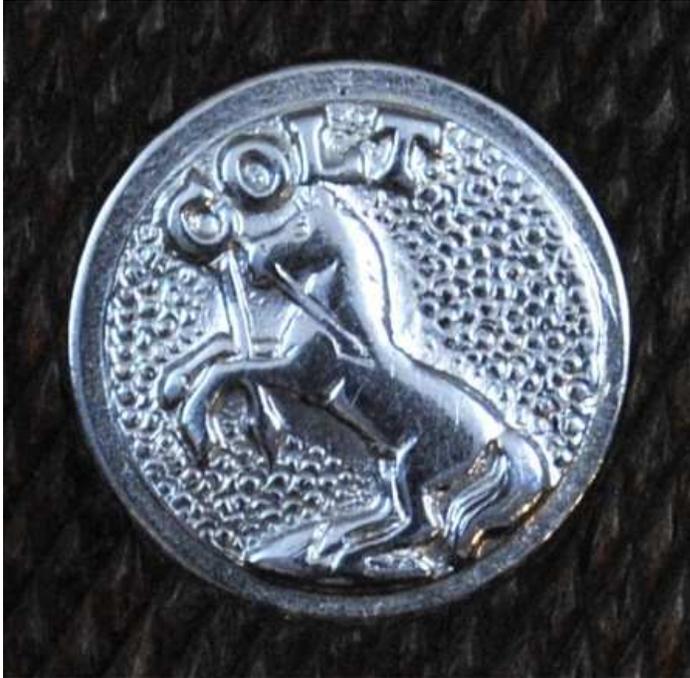
First variation medallion used on the Python target grips. Note the flat edge and the raised artwork.

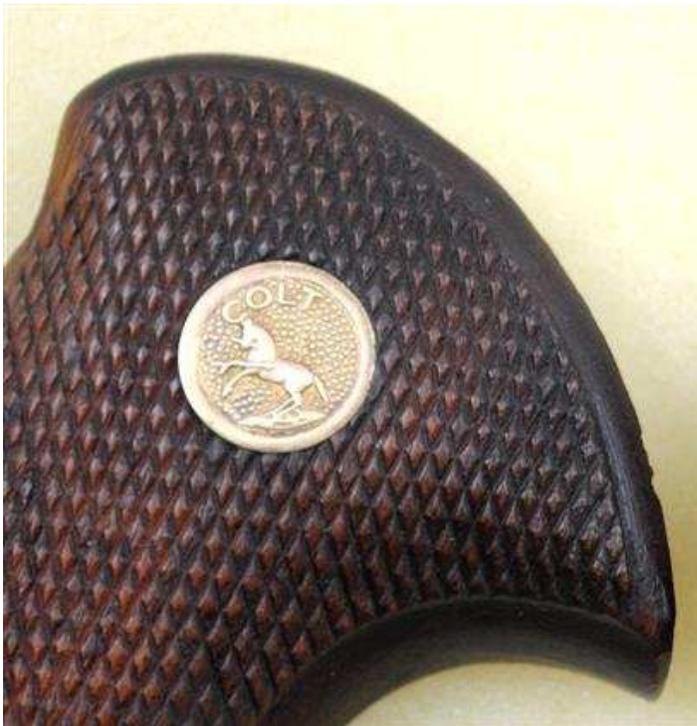
Second variation medallion used on the Python target grips. Note the rounded edge and the recessed artwork.

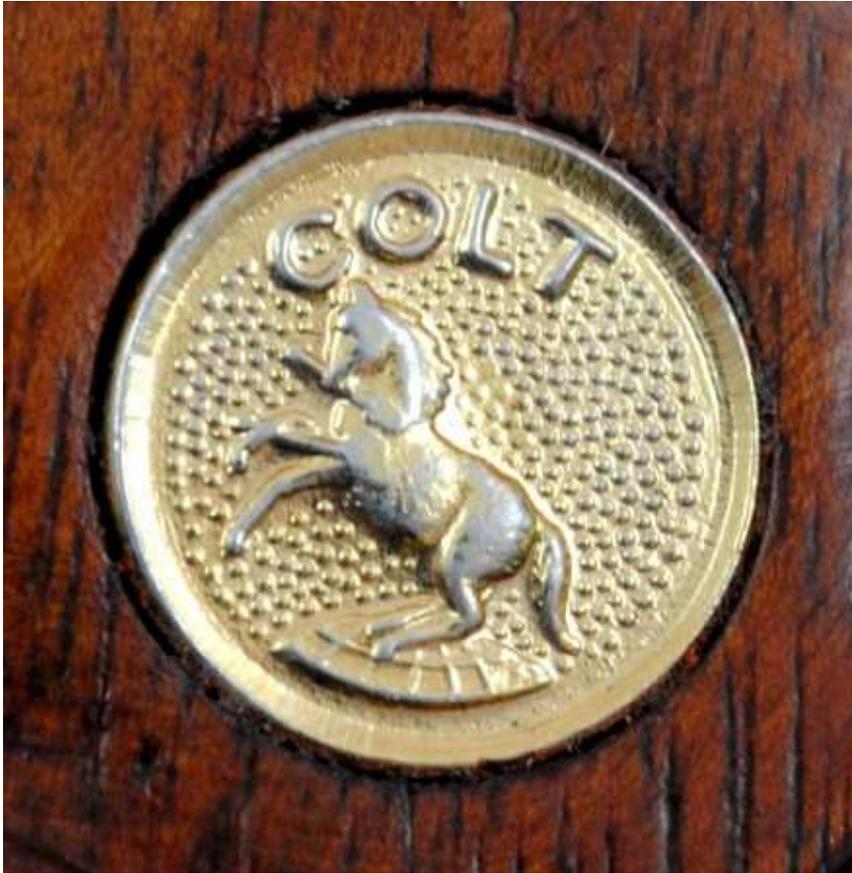
Third variation medallion used on the Python target grips. Note the beveled edge and the recessed artwork. Also note the position of the horse's head in relation to the "COLT" text. A slightly different variation of this medallion (still in production in 2018) shows the horse slightly turned, with the head under the "L".

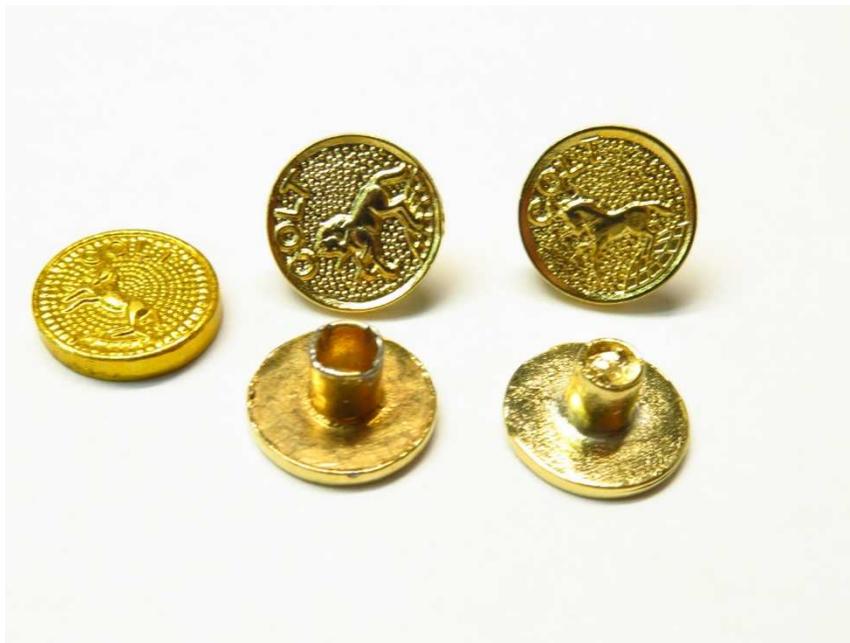
Some reproduction medallions of different origin. The one to the far left is a simple, glue-in type with an odd, concentric pebble pattern. The other ones look fairly good at first glance, but you can still tell that they are cheap castings. The one in the bottom right corner is so poorly cast that the stem is not even hollow. This means that it can't be staked, and many times you will find these glued in.

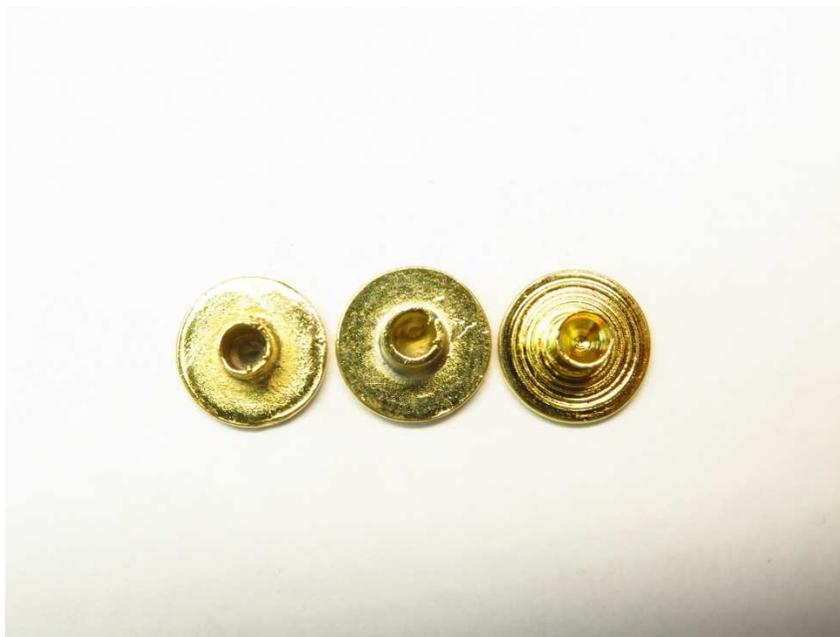
Two reproductions to the left and an original to the right. The difference in diameter is not very noticeable in the picture, but will become obvious once you try to install them. The one to the left is too small and will leave a gap around the perimeter, the one in the center is too large and won't even fit in the recess.

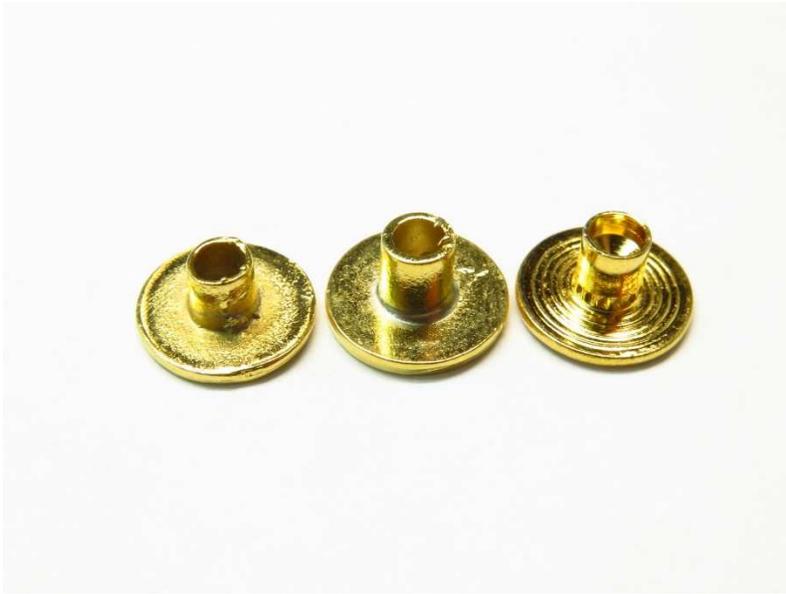
Same medallions from the side, and here you can see the difference in thickness and stem length. Also note the knurled stem section on the original to the right, this is a feature you rarely see on reproductions.

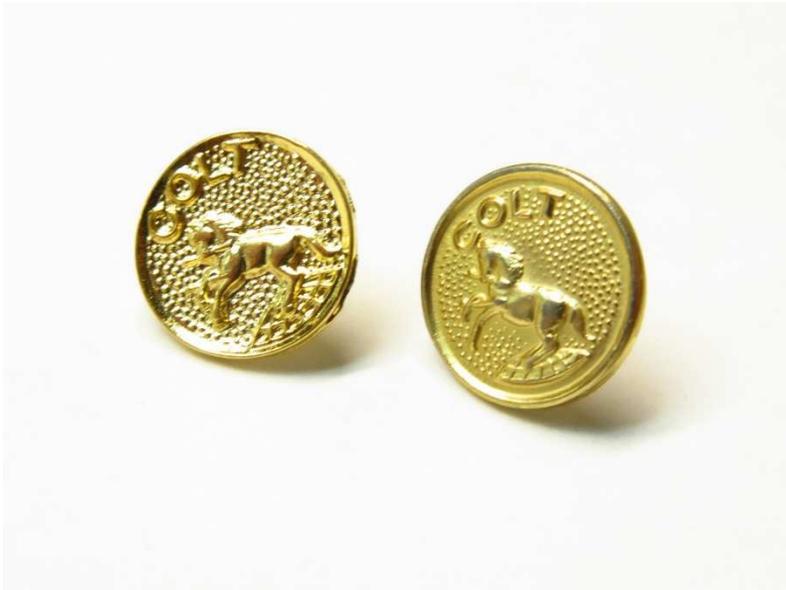
Reproduction to the left, original to the right. Note the “blurry” appearance of the reproduction, and the jagged casting flash around the edge. What you can’t see in the picture is that the reproduction is about .010”-.015” smaller in diameter, which leaves a noticeable gap around the perimeter when installed. Also note the difference in sheen in these particular medallions. I think it’s safe to say that the original medallions always left the factory with a high sheen, but most of them have a more or less faded look due to their age. A high sheen does not necessarily mean that it’s a reproduction, but it’s a red flag if you find them on grips in less than perfect condition.

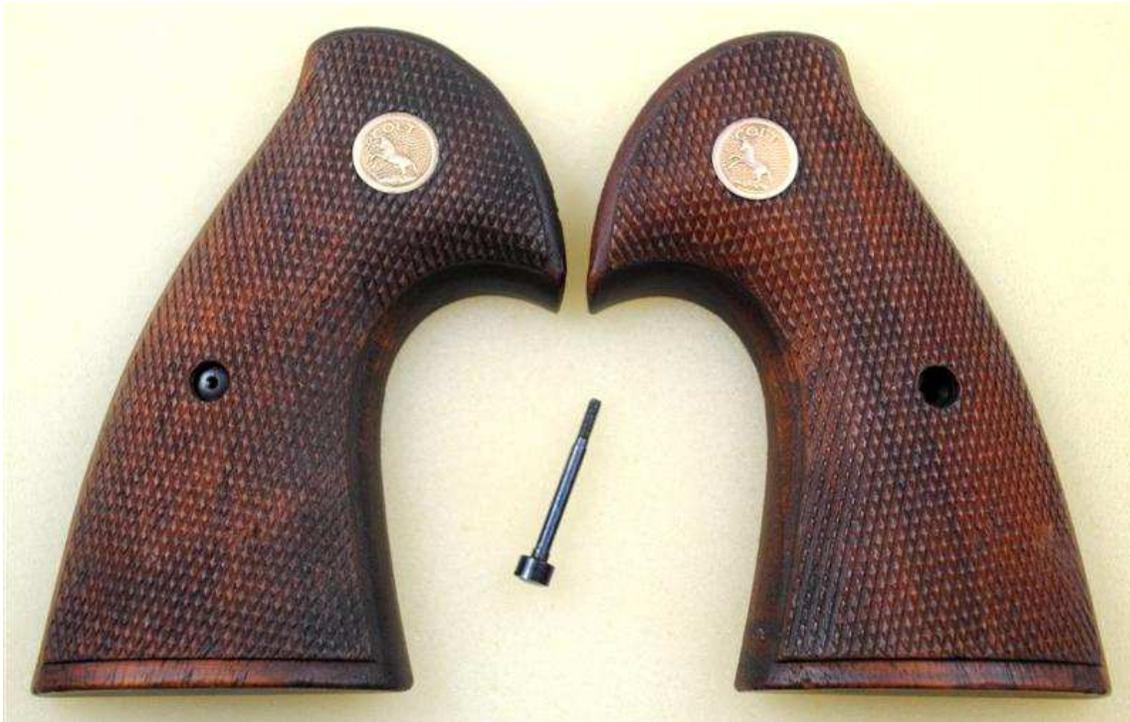
1st gen Python grips, front.

These are easily recognizable, as they are fully checkered with just a thin, smooth border around the perimeter. The backs are either flat, or on later examples cut with the same style fitting pads as on gen 2. The panels are symmetrical from side to side.

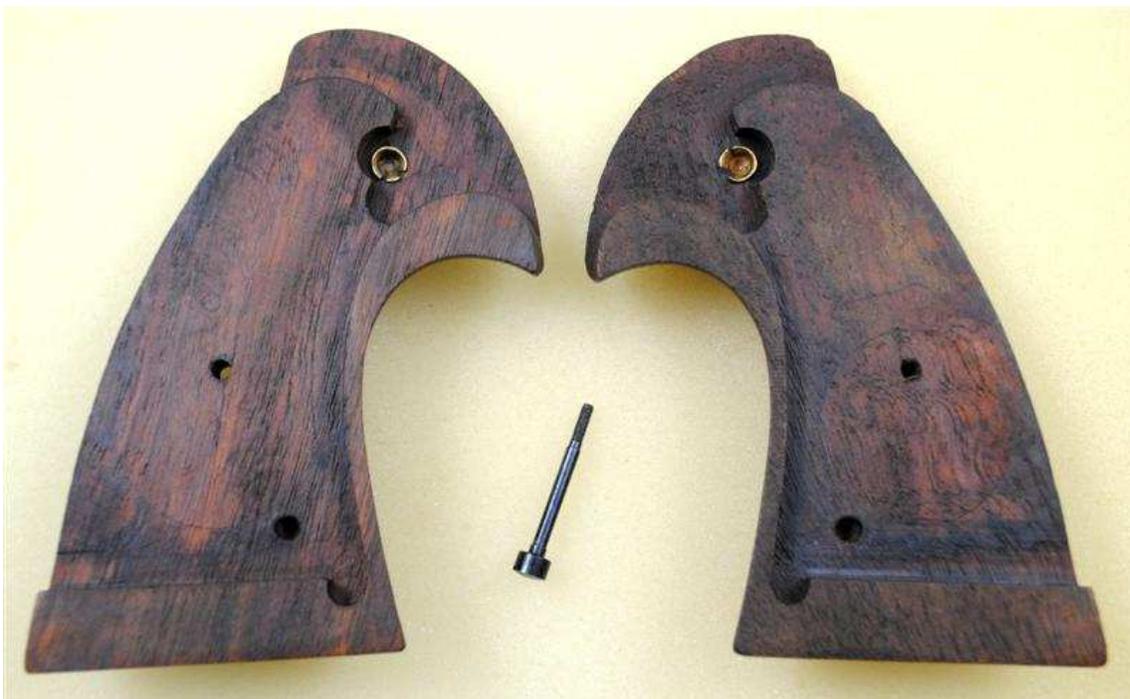
1st gen Python grips, back. The picture shows the early variation with flat back.

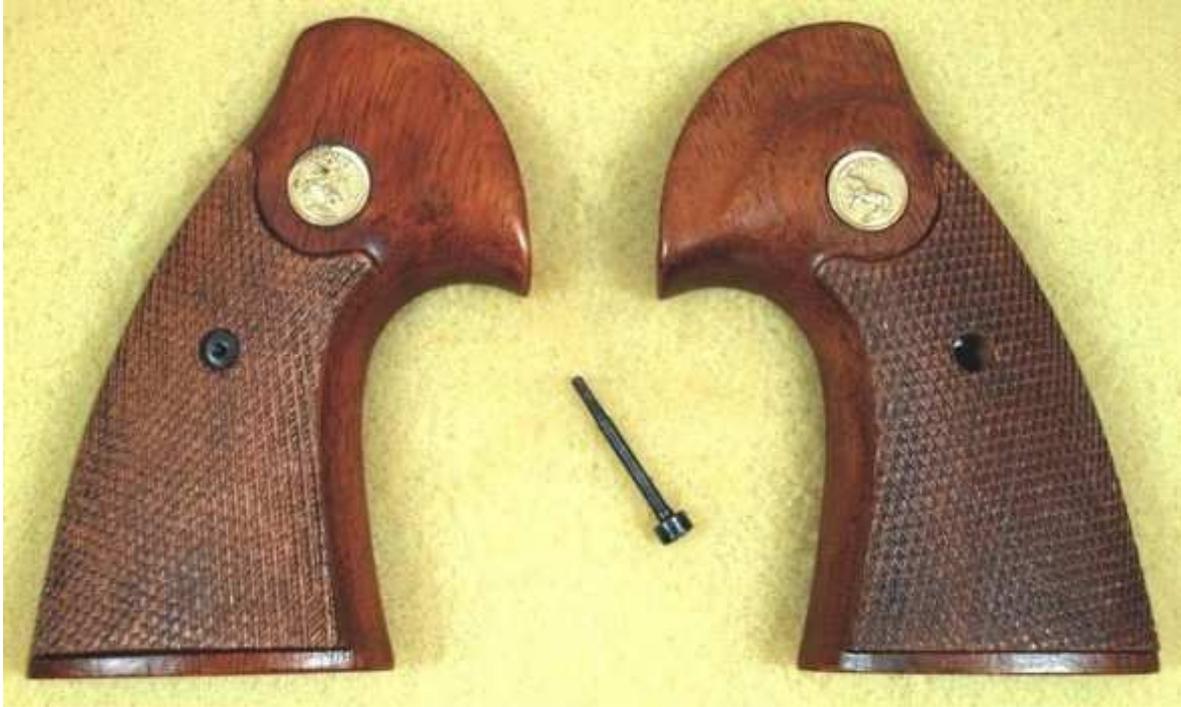
2nd gen Python grips, front. Note how the checkering wraps around the bottoms of the medallions.

The most distinguishing feature is that the top edge of the checkered area has a curved shape that wraps around the bottom of the medallion, which is why the gen 2s are sometimes called “smiley face grips”. The backs are cut with fitting pads, which allow for trimming to the thickness of the frame and also provide clearance for the rebound lever pin. The left panel has a thumb cut, sometimes referred to as a speed loader cut.

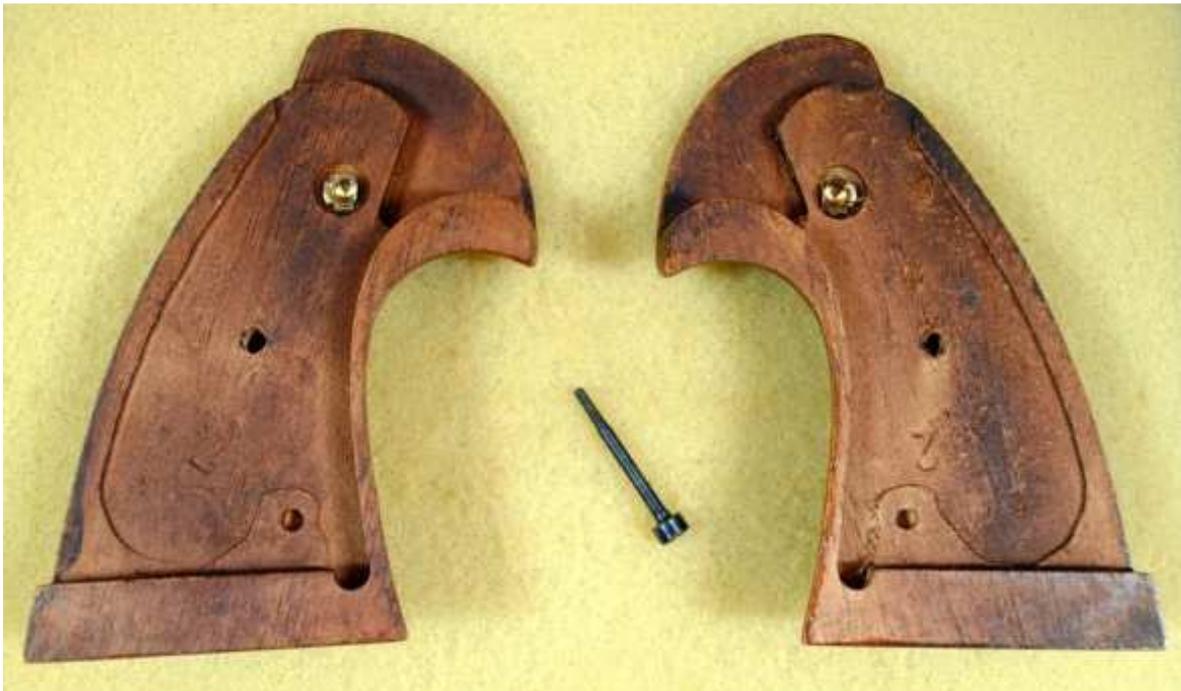
2nd gen Python grips, back. Note the fitting pads along the rear edges and the pin holes.

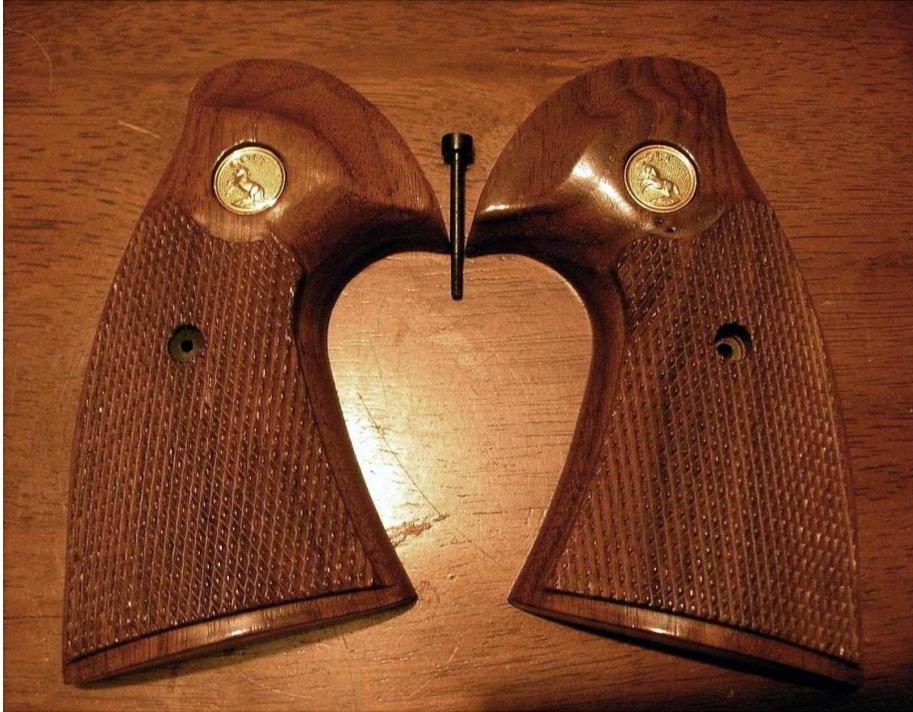
Transitional 2nd gen Python grips, front. Note the symmetrical panels with thumb cut

These look like gen 2 grips at first glance, but have thumb cuts on both sides. These were used very briefly, and (strangely enough) they have the same “fat” cross section and flat back cuts as the gen 3 introduced in 1979. This variation appears to be identical to gen 3, but with the “smiley face” checkering like on gen 2. The wood is normally light in color, and the sanding and finishing usually doesn’t show the same level of craftsmanship as on gen 2.

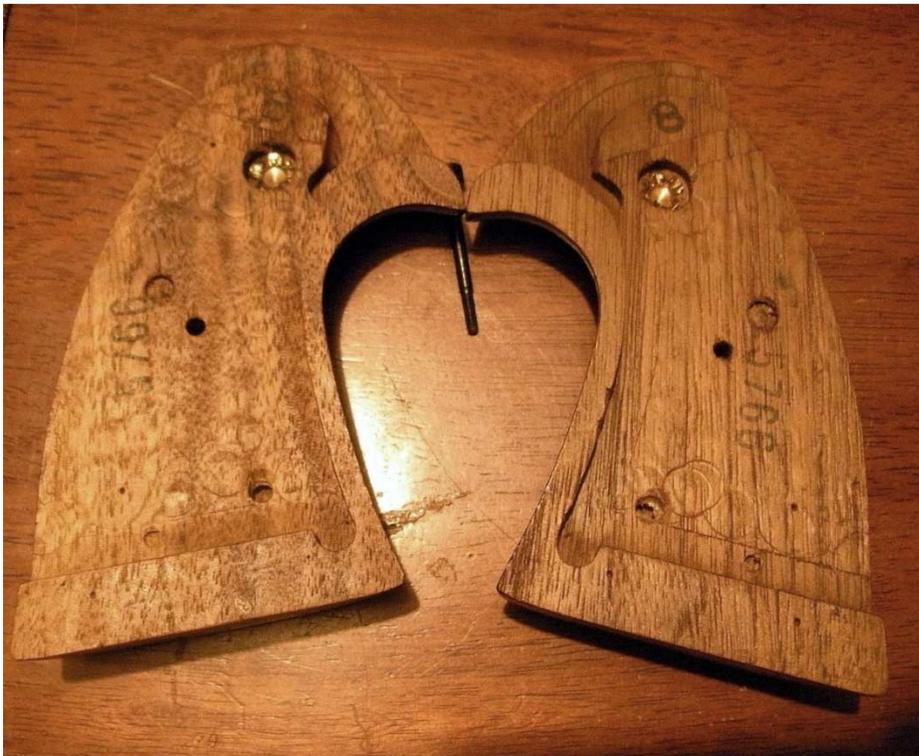
Transitional 2nd gen Python grips, back. Note the lack of fitting pads, the backs are very similar to late gen 3.

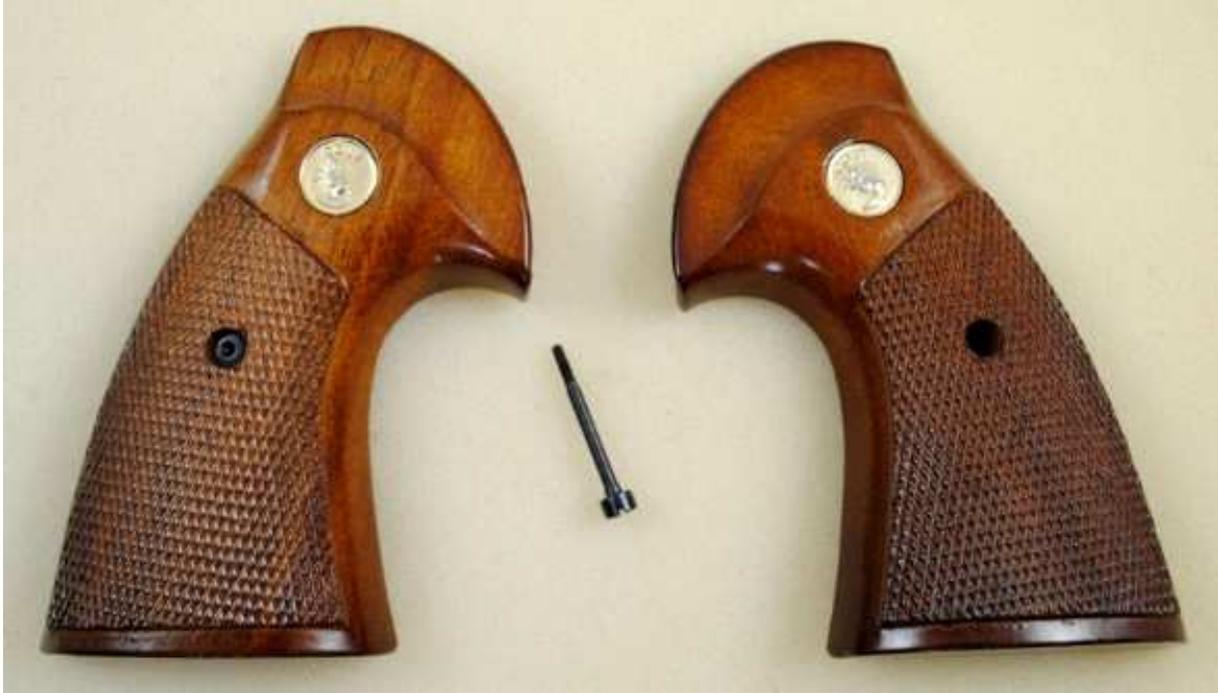
Early 3rd gen Python grips, front. Note the rounded upper corners of the checkering and the large thumb cuts.

- 1: The upper corners of the checkered area are rounded, whereas 3rd generation has sharp corners.
- 2: Seen from the bottom, these grips are shaped like a continuous oval like on gen 2, whereas the 3rd generation has a compound curve shape with more or less pronounced corners where the curves meet.
- 3: The thumb cuts are larger than on gen 3, so this variation is sometimes called “large ear grips”.

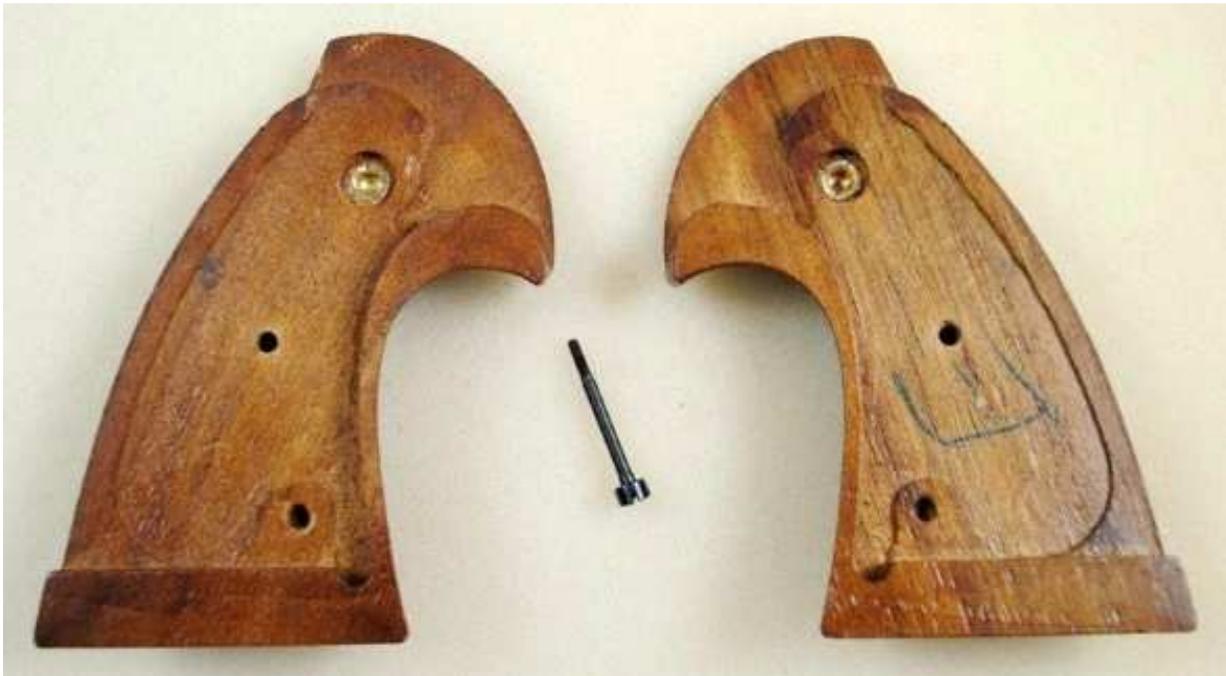
Early 3rd gen Python grips, back. Note that the fitting pads from gen 2 are still present (or rather re-introduced, if you compare with the transitional gen 2). Also note the light colored wood, which is a typical feature of this variation.

This variation looks very similar to gen 3, but has the early style backs with fitting pads, like on gen 2. All early gen 3 grips I have seen were made of mahogany and sprayed with a dark tint to resemble walnut. They are often confused with the later gen 3 (or even mistaken for reproductions), but the following details make them easy to recognize:

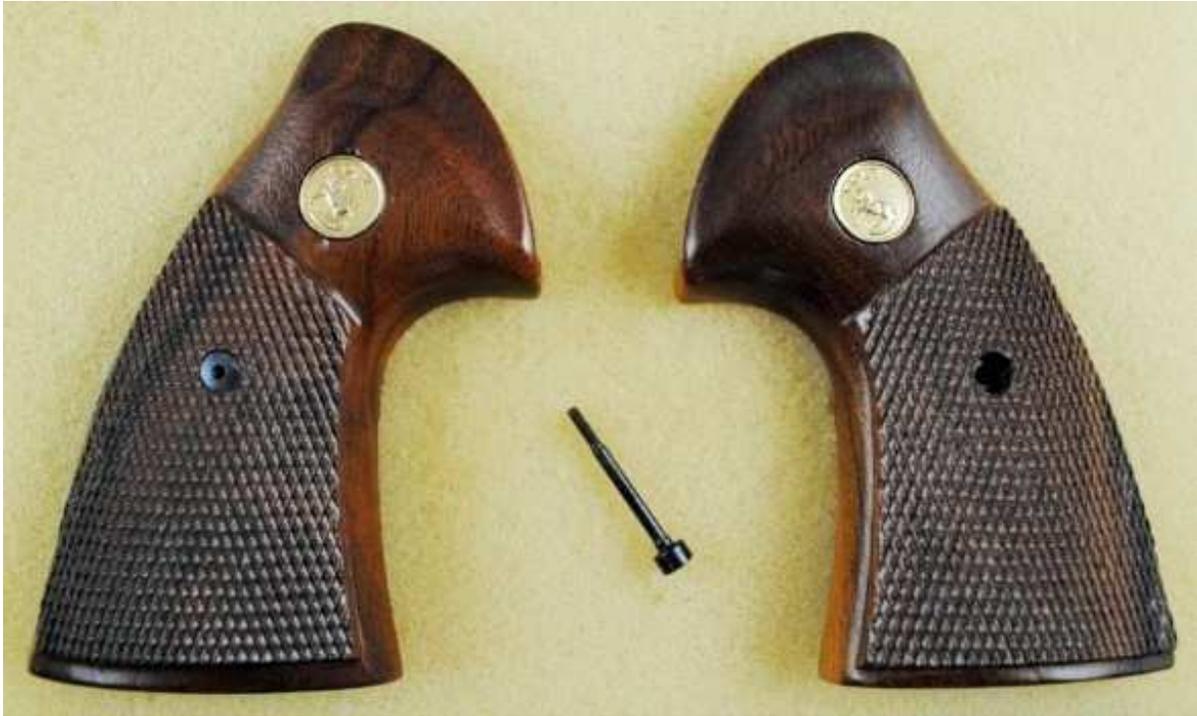
Late 3rd gen Python grips, front. Note the square upper corners of the checkering and the smaller thumb cuts. Also note the somewhat rough finish, which is typical for many of these.

These grips are symmetrical with thumb cuts on both sides, and the checkered area has square corners. The backs are flat without fitting pads, and have circular recesses to clear the pin for the rebound lever. There is also a shallow clearance cut at the top “half moon”. Within this variation, I have observed that the width of the bottom border under the checkered area can vary quite a bit, sometimes to the point of “looking funny”. You will also find some gen 3 grips with a somewhat “blocky” look where the rounded surfaces are not blended in properly.

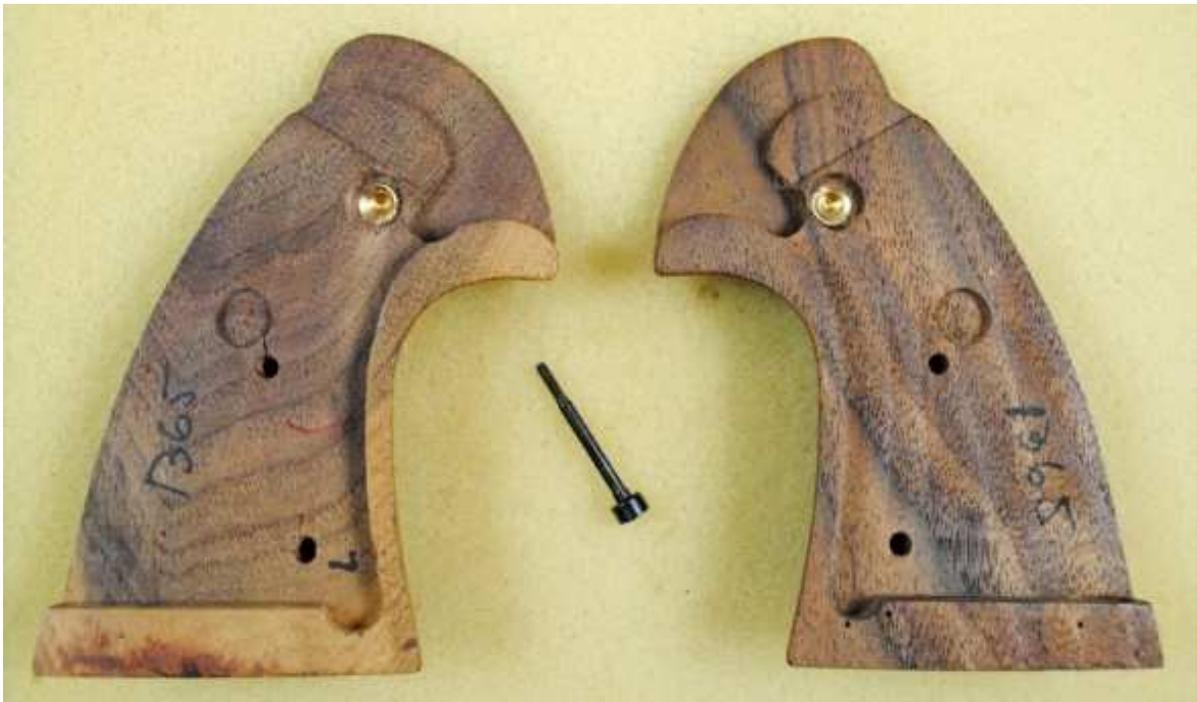
Late 3rd gen Python grips, back. Note the flat backs, the circular relief cuts for the rebound lever pin and the straight relief cut above the medallions.
